Borough of Wildwood Crest
Cape May County, New Jersey

Bulkhead & Beach Outfall Evaluation

November 2017

**DEBLASIO &
ASSOCIATES**

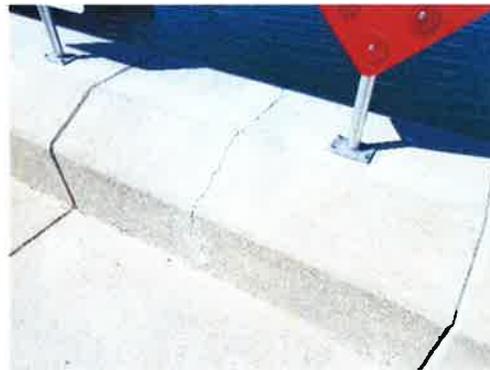
There are medium cracks in the concrete kneewall above the sheeting.

- 1. Medium cracks in the concrete kneewall above the sheeting.

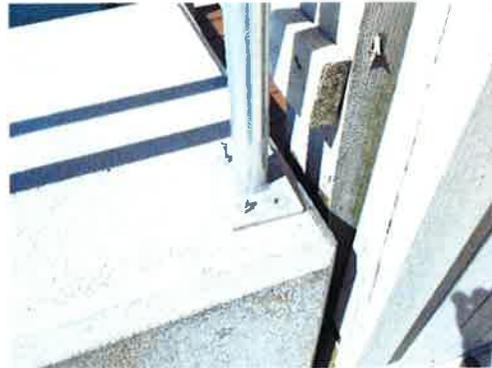
The bolts connecting the safety railing to the concrete kneewall have not been cut flush with the installed nuts presenting a snag or cutting hazard.

1. The bolts connecting the railing to the kneewall have not been cut flush.

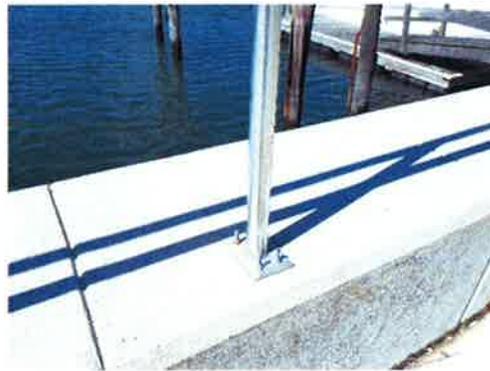
The bolts connecting the safety railing to the concrete kneewall have not been cut flush with the installed nuts presenting a snag or cutting hazard.

1. The bolts connecting the railing to the kneewall have not been cut flush.

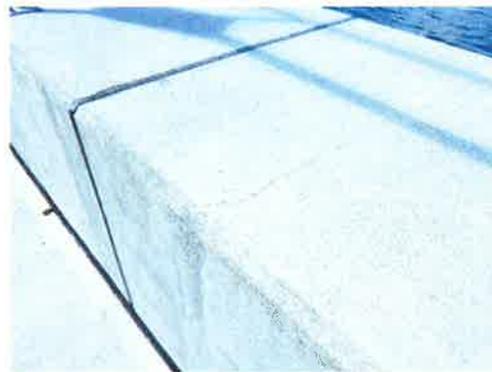
There are fine cracks in the top of the concrete kneewall above the sheeting.

- 1. Fine crack in the top of the concrete kneewall

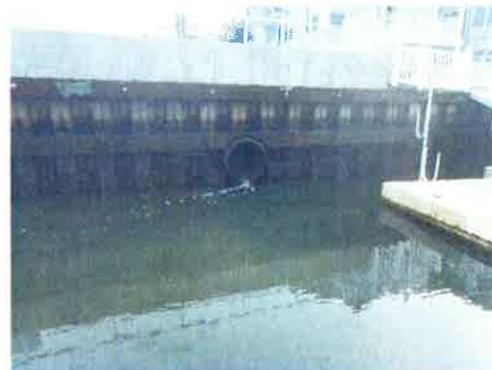
- 2. Existing outfall without check valve.

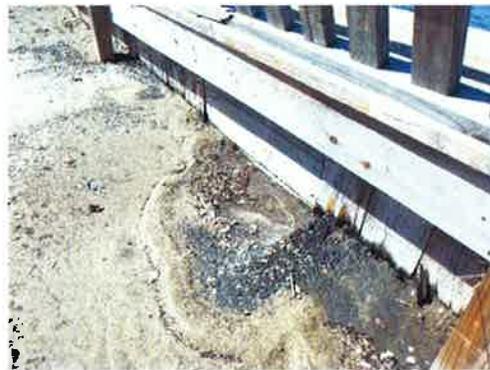
1. Previously repaired areas on the rear face of the timber bulkhead.

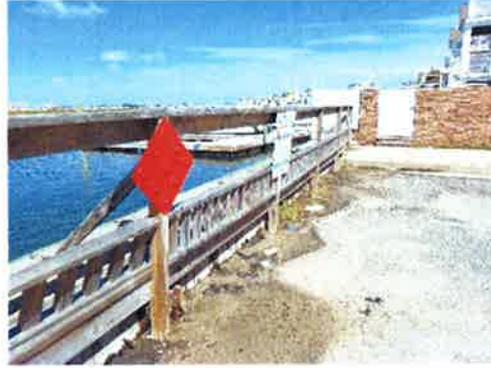
2. Accumulated sediment & debris against the rear timber face of the bulkhead.

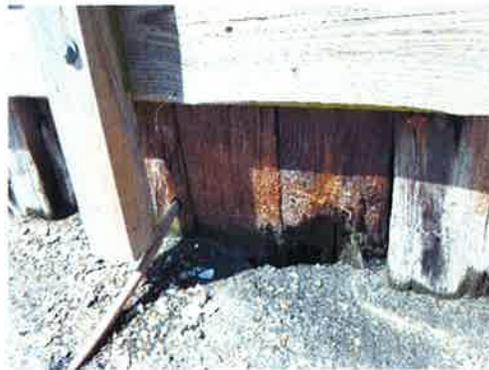
2. Medium area of deterioration in the rear face.

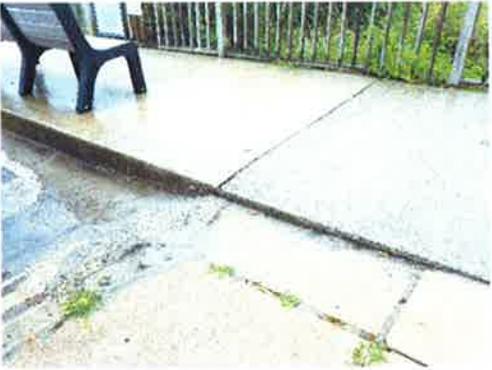
<p>3. Settlement of the approach sidewalk.</p>

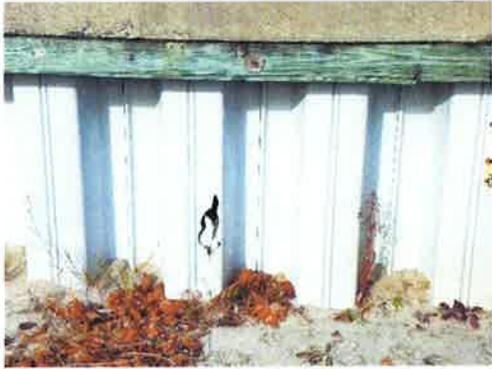
A photograph showing a bulkhead with a hole in the vinyl sheet. The hole is located near the bottom of the sheet. A void is visible behind the sheet, and there is some debris on the ground in front of the bulkhead.

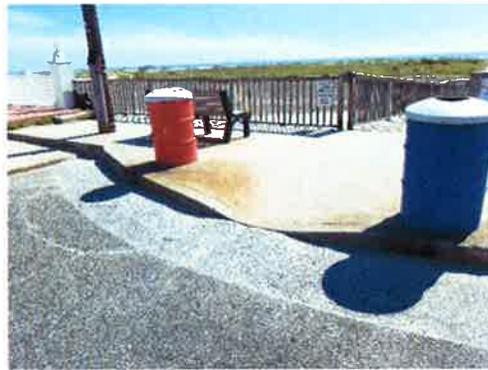
The existing sidewalk does not contain an ADA-compliant access ramp.

1. Non-compliant curb ramp.

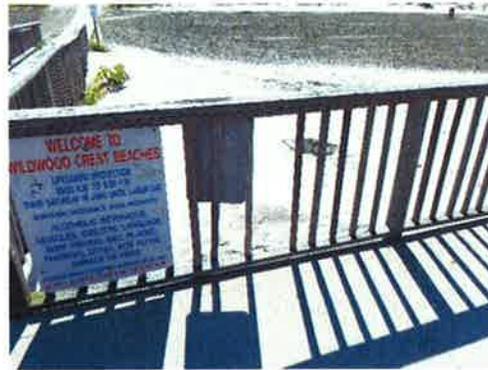
2. Missing spindles in the safety railing.

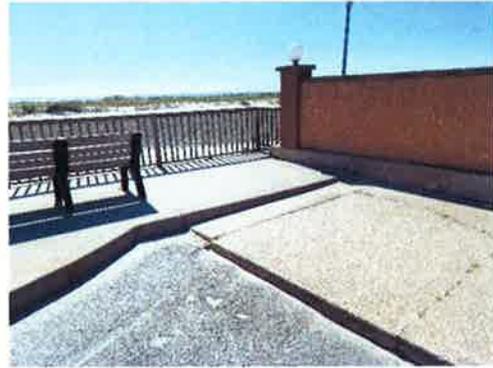
3. Settlement at the approach sidewalk.

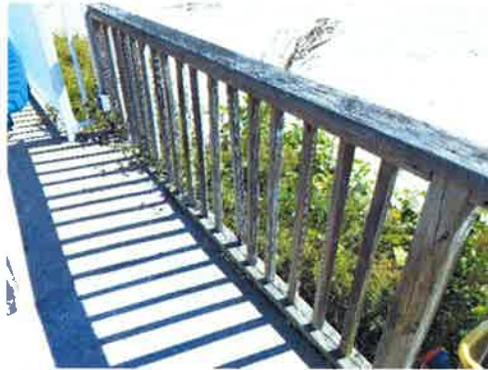
- 2. Medium splits and checks in timber posts of safety railing.

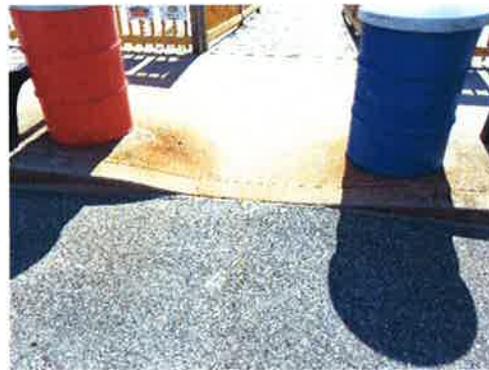
The existing sidewalk does not contain an ADA-compliant access ramp.

1. Non-compliant curb ramp at street end.

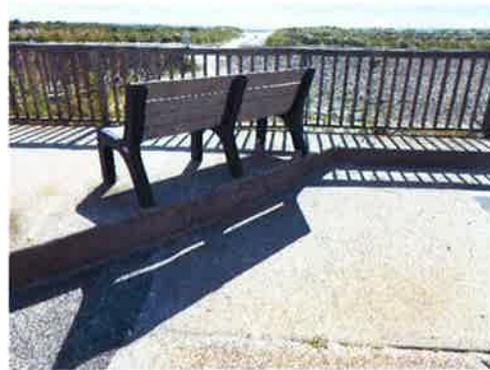
- 2. Excessive height curb at approach sidewalk.

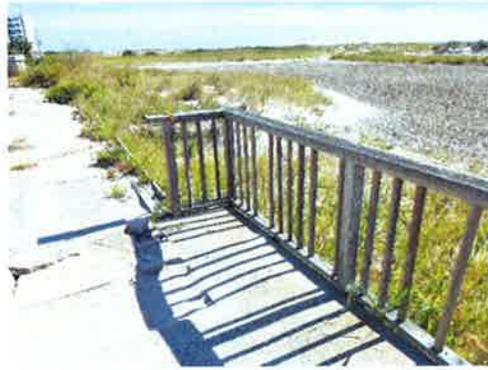
3. Missing spindles in safety railing.

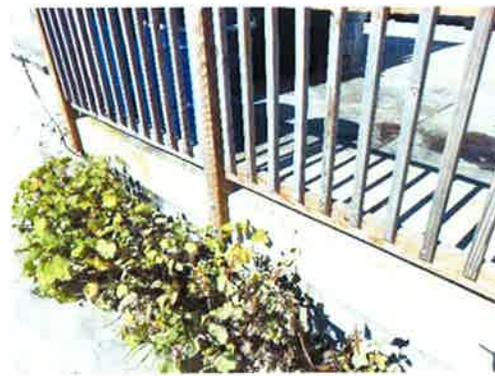
- 1. Large spall in the concrete slab above the bulkhead face.

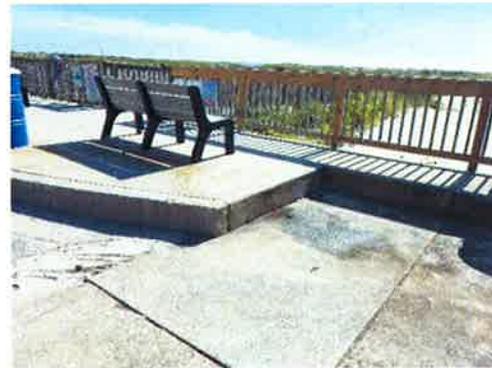
- 2. Excessive height curb at approach sidewalk.

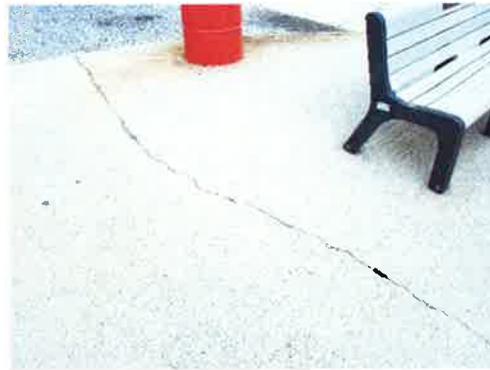
- 1. Medium-wide transverse crack along existing sidewalk.

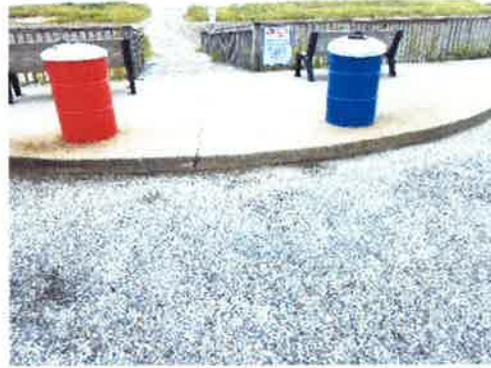
4. No ADA-complaint ramp in existing sidewalk

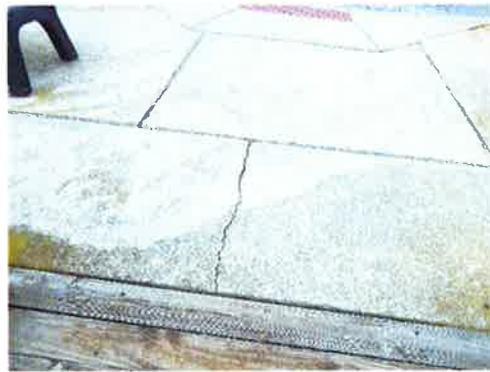
- 1. Medium-wide transverse crack along existing sidewalk.

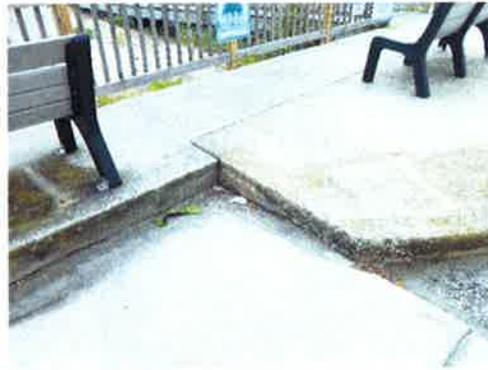
3. Excessive height curb at approach sidewalk.

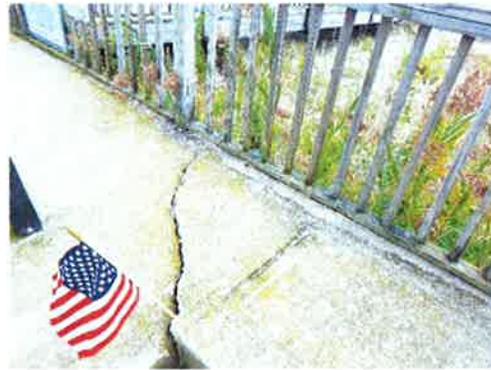
- 1. Wide transverse crack along existing sidewalk.

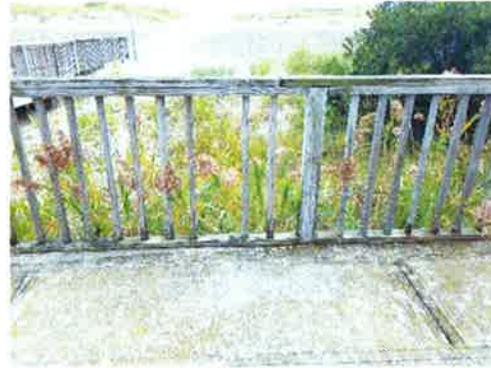
- 2. Missing spindles in safety railing.

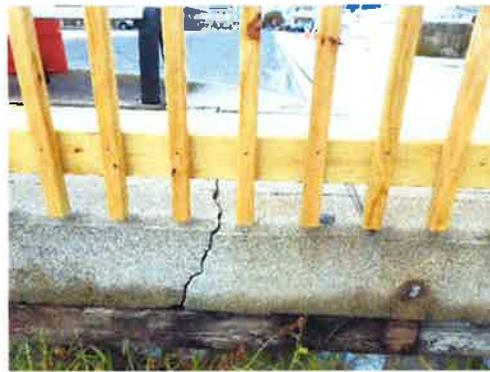
- 1. Wide transverse crack along existing sidewalk.

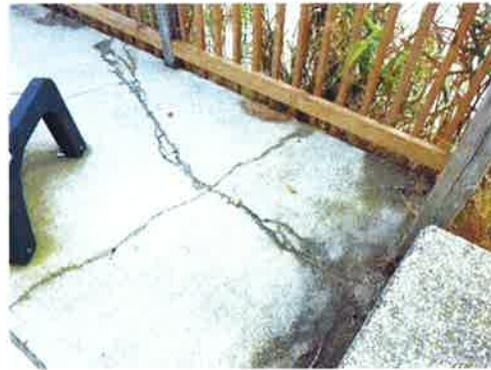
1. Medium-wide transverse crack along existing sidewalk.

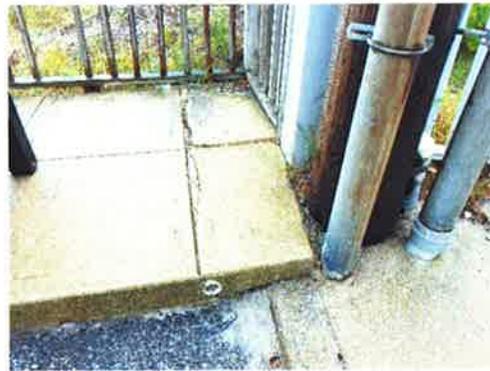
- 1. Medium-wide transverse crack along existing sidewalk.

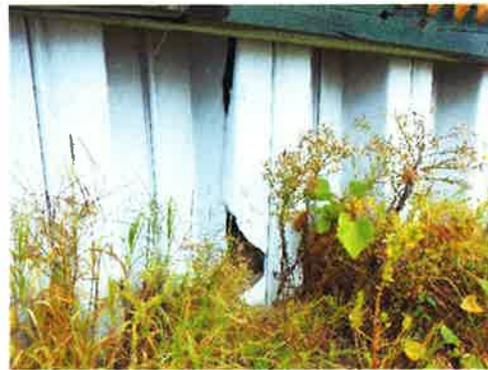
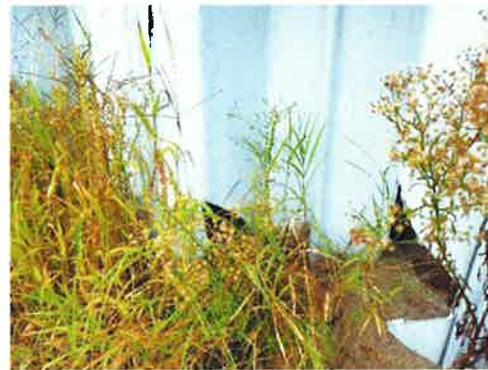
One of the vinyl sheets on the north side is split and broken. Backfill material has started to migrate through the hole, creating a void behind the sheet.

4. Broken vinyl sheet in the face of the bulkhead. Backfill material has started to migrate through the hole, likely creating a void behind the sheet.

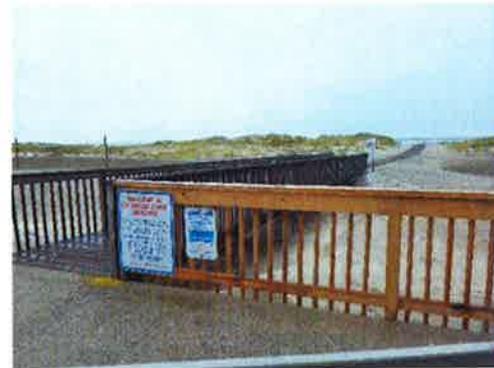
4. Recently replaced section on safety railing on the south side of the beach access.

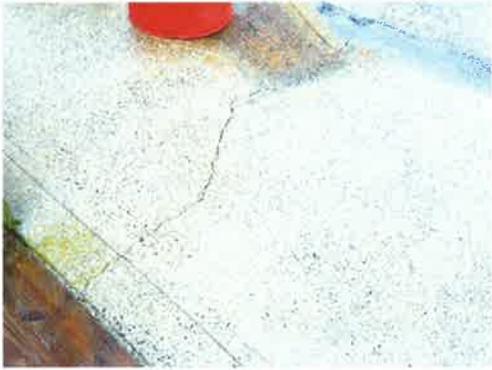
<p>3. Medium crack in the street end sidewalk</p>

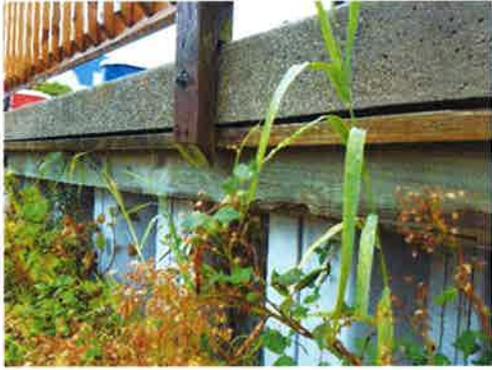
<p>4. Medium split in the timber waler</p>
