Borough of Wildwood Crest
Cape May County, New Jersey

Bulkhead & Beach Outfall Evaluation

November 2017

**DEBLASIO &
ASSOCIATES**

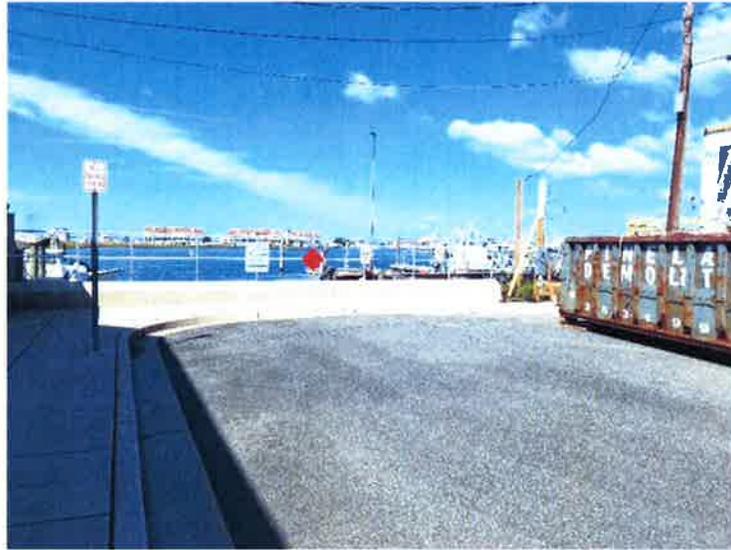
Looking west

The overall condition of this vinyl bulkhead is very good.

There are medium cracks in the concrete kneewall above the sheeting.

There are two (2) existing stormwater outfalls protruding through the face of the bulkhead. Neither of the existing outfalls are fitted with check valves to prevent the backflow of saltwater into the stormwater system.

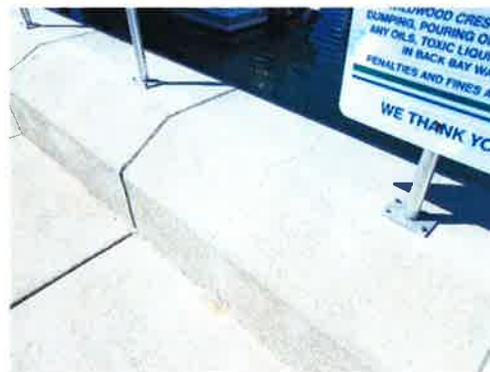
- 1. Medium cracks in the concrete kneewall above the sheeting.

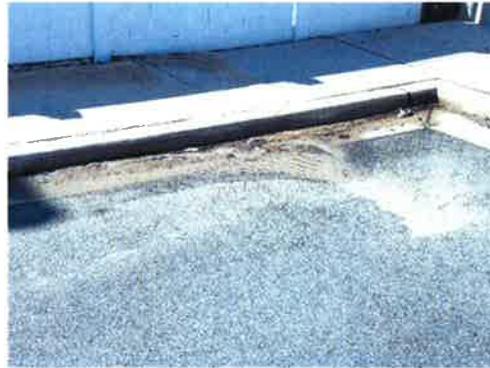
1. Accumulated sediment on the north side of the street and gutter.

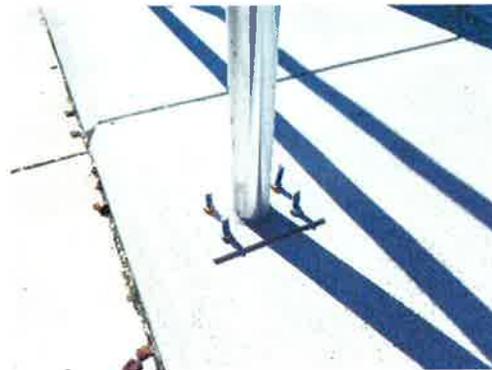
1. The bolts connecting the railing to the kneewall have not been cut flush.

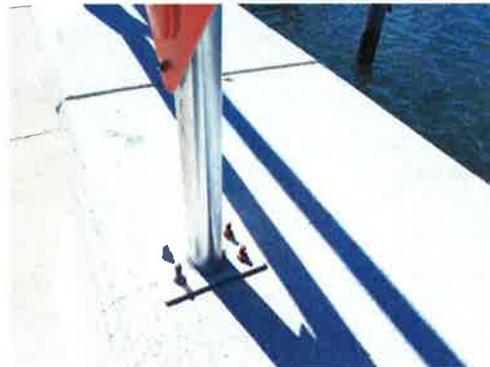
2. Fine crack in the top of the concrete kneewall

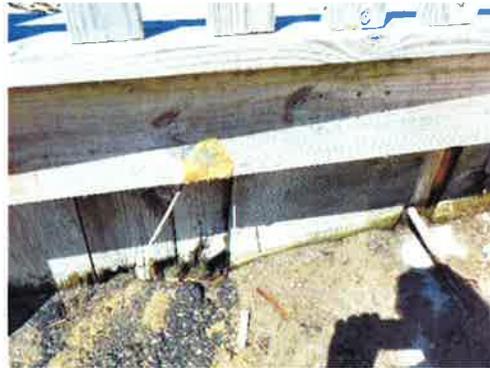
1. Previously repaired areas on the rear face of the timber bulkhead.

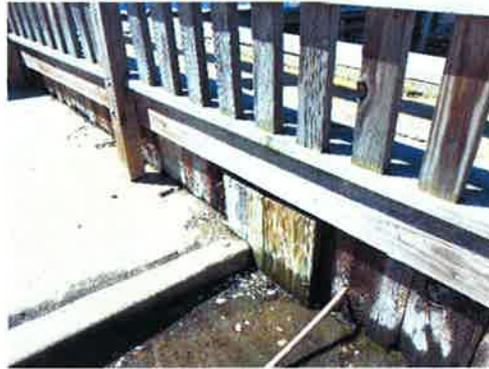
1. Previously repaired area near the north curbline.

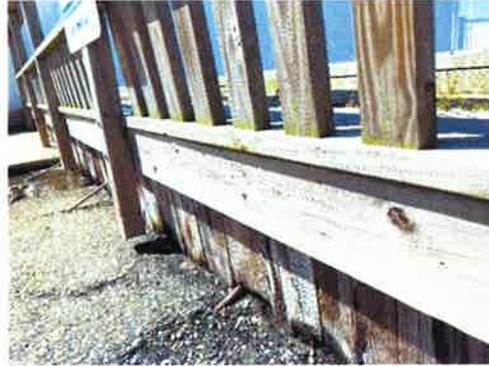
3. Numerous checks and splits in the rear timber face.

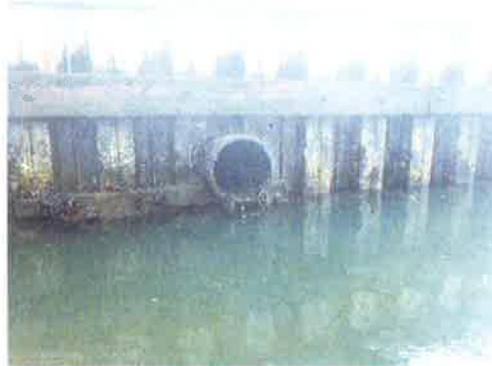
1. Existing outfall without check valve to prevent backflow into the stormwater system.

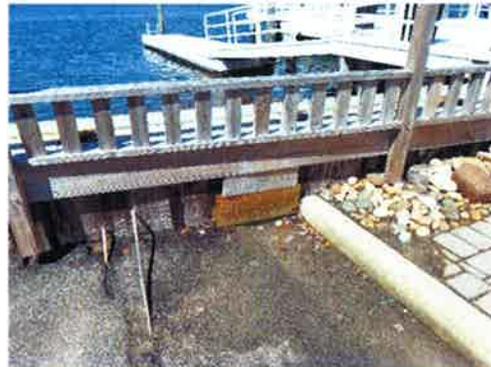
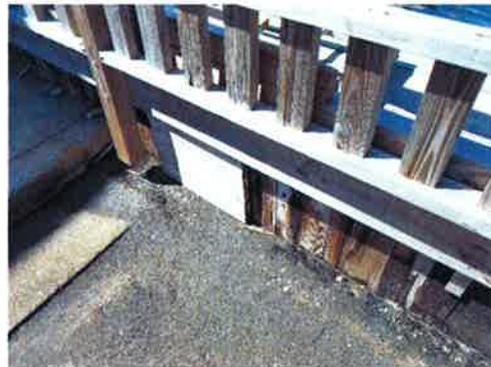
1. Previously repaired areas in the rear timber face of the interior bulkhead.

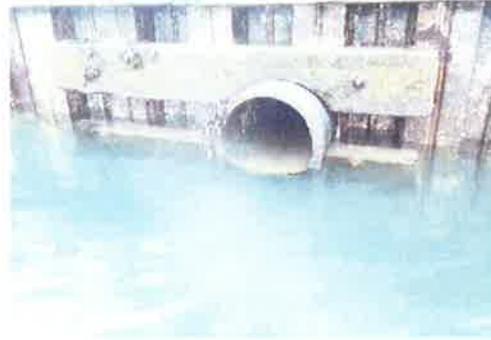
2. Existing outfall without check valve to prevent backflow into the stormwater system.

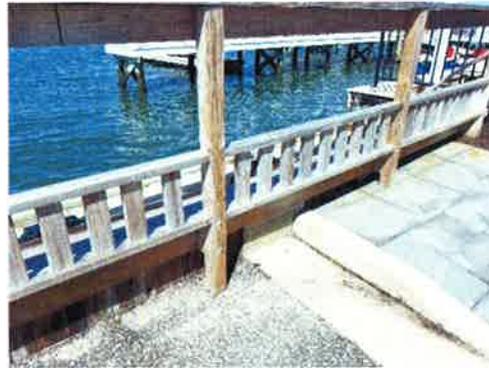
1. Repaired area in the rear face of the timber section of the bulkhead.

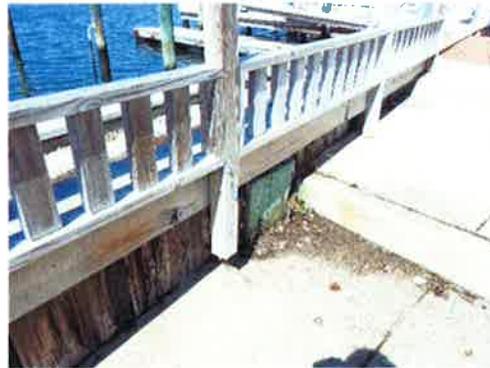
1. Previously repaired area in the rear face of the timber portion of the bulkhead.

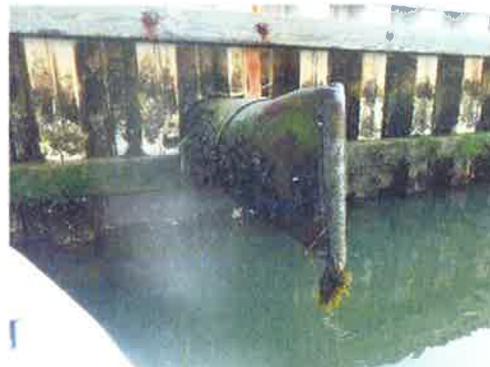
2. Existing check valve clogged with debris.

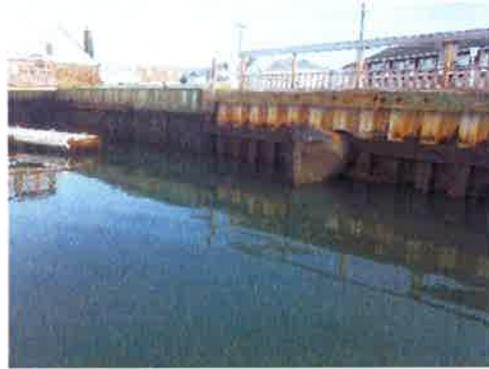
1. Existing check valve on stormwater outfall.

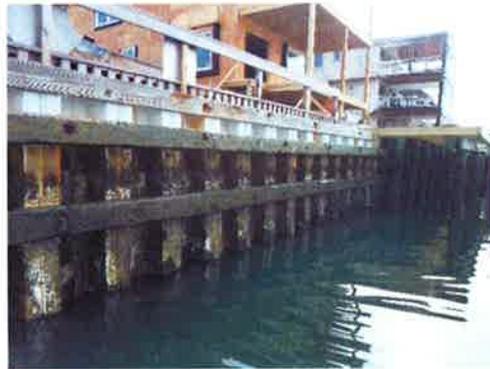
The overall condition of the existing timber walers is satisfactory. There are fine to medium checks and splits in the walers, which is typical of timber members used in this type of application.

- 1. Overall view of existing timber walers.

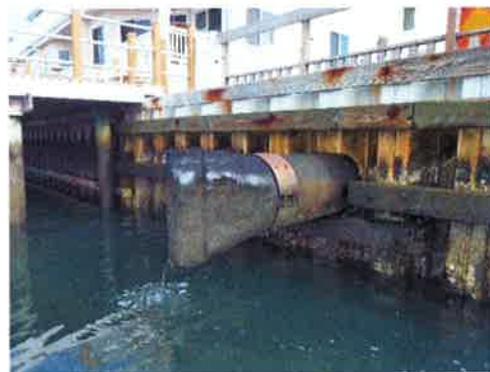
- 2. Existing check valve.

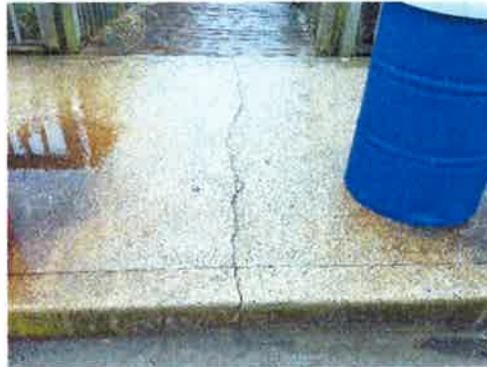
There are medium to wide cracks in the existing sidewalk at the street end. There is also evidence of settlement at each end of the existing sidewalk creating a tripping hazard.

- 1. Medium-wide transverse crack along existing sidewalk.

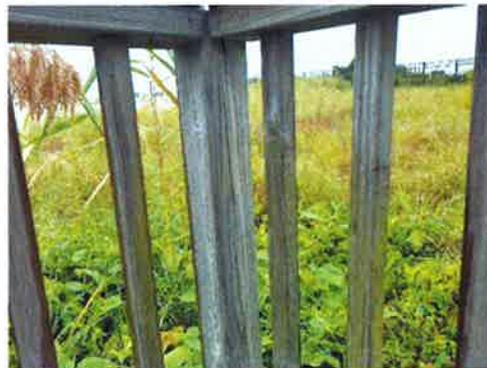
- 2. Medium splits and checks in timber posts of safety railing.

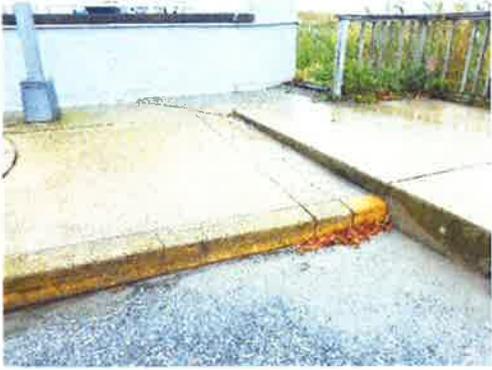
A photograph showing a concrete sidewalk with a significant settlement. The concrete is cracked and uneven, with a dark, possibly wet or shadowed area where the concrete has sunk. A black plastic chair is visible in the background on the higher part of the sidewalk.
<p>4. Settlement of the approach sidewalk.</p>

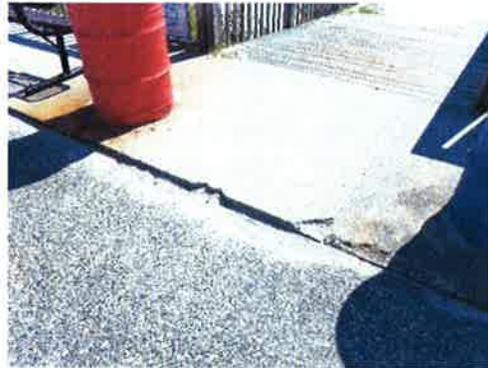
The existing sidewalk does not contain an ADA-compliant access ramp.

- 1. Non-compliant curb ramp.

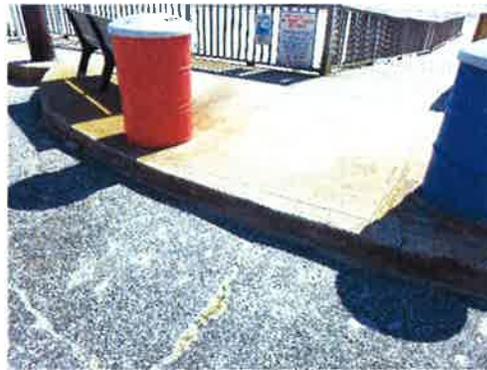
The existing sidewalk does not contain an ADA-compliant access ramp.

- 1. No curb ramp at street end.

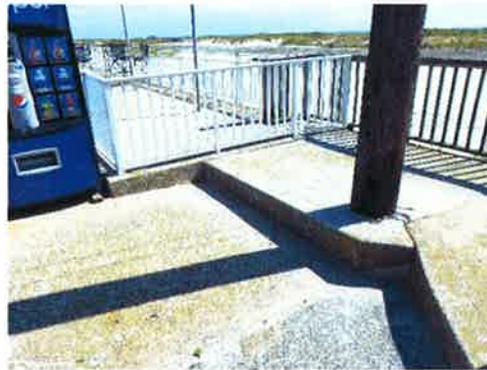
- 2. Excessive height curb at approach sidewalk.

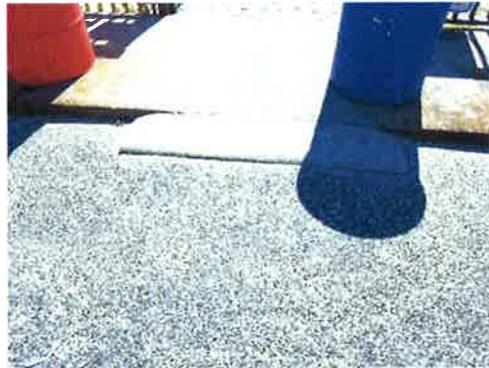
The existing sidewalk does not contain an ADA-compliant access ramp.

1. Non-compliant curb ramp at street end.

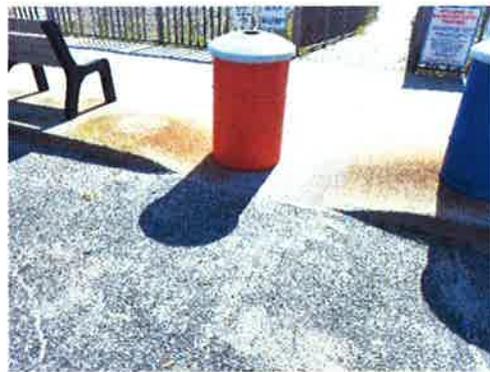
The existing sidewalk does not contain an ADA-compliant access ramp.

- 1. Non-compliant curb ramp at street end.

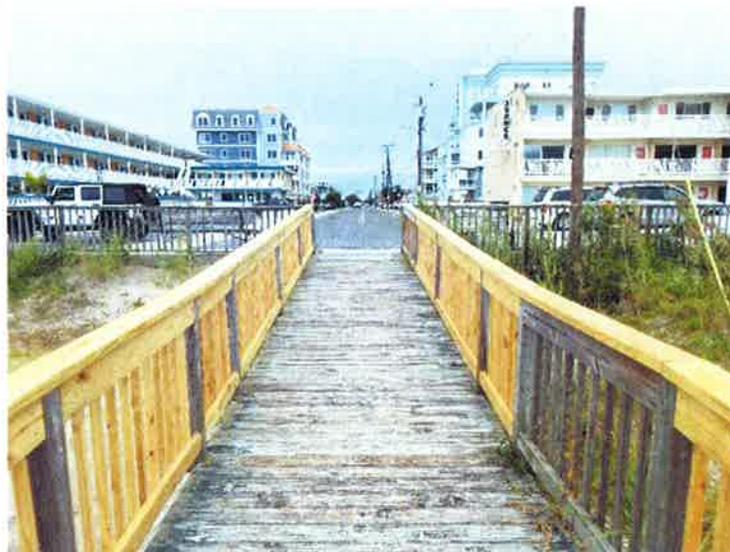
Looking west

The overall condition of this vinyl bulkhead is good. There is up to 18-inches of sheeting exposed on the beach side. The existing timber safety railing is in satisfactory condition.

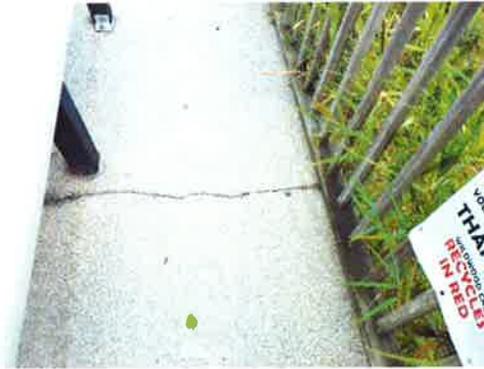
- 1. Medium-wide transverse crack along existing sidewalk.

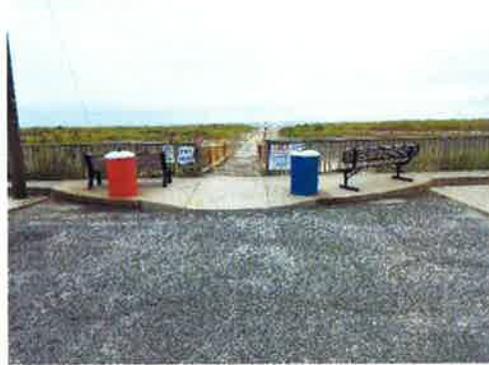
- 2. No detectable warning surface on existing ADA-compliant ramp.

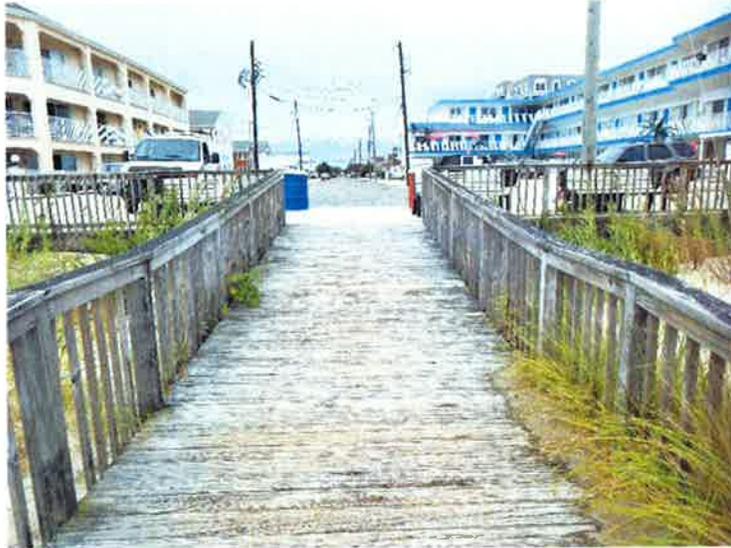
Looking west

The overall condition of this vinyl bulkhead is good. There is up to 18-inches of sheeting exposed on the beach side. The existing timber safety railing is in good condition. However, there is one missing spindle on the north side on the beach entrance.

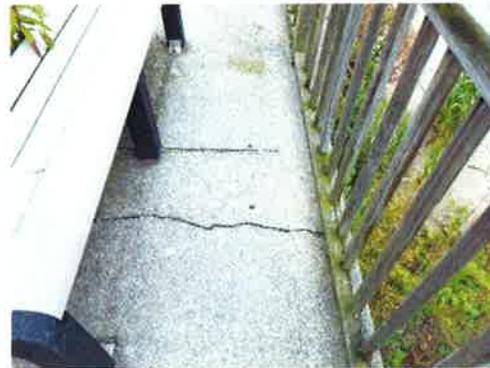
- 2. More transverse cracking in existing sidewalk

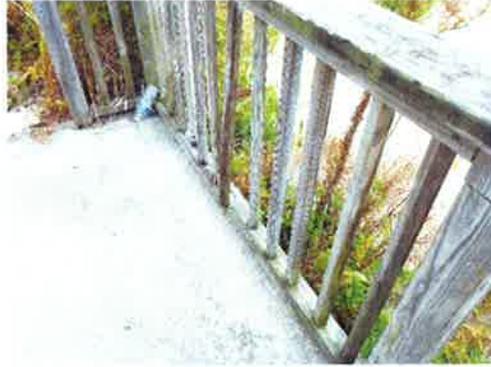
3. Missing and broken spindles on north side of safety railing

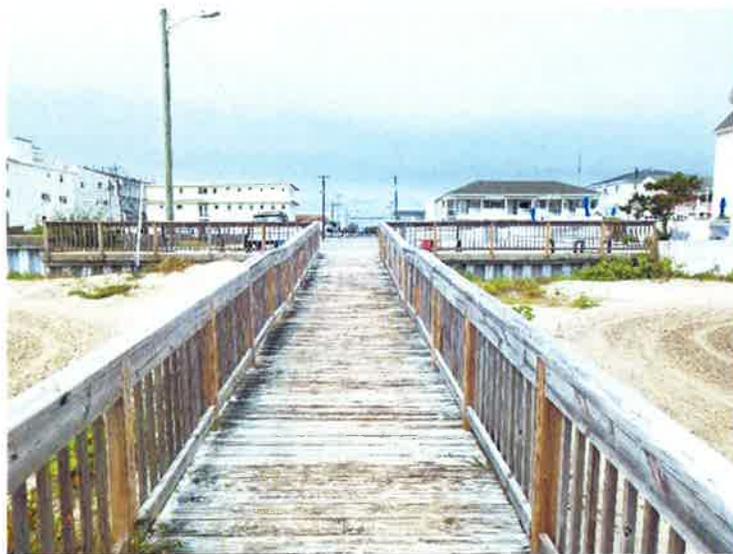
Looking west

The overall condition of this vinyl bulkhead is good. There is approximately 12-inches of sheeting exposed on the beach side. There is heavy vegetation present along the face of the sheeting. The existing timber safety railing is in satisfactory condition with some medium checks and splits in most of the posts.

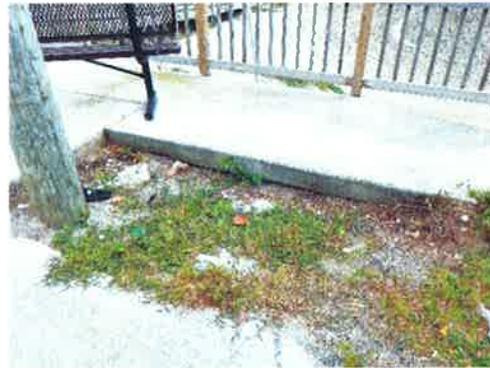
- 2. Excessive height curb at approach sidewalk.

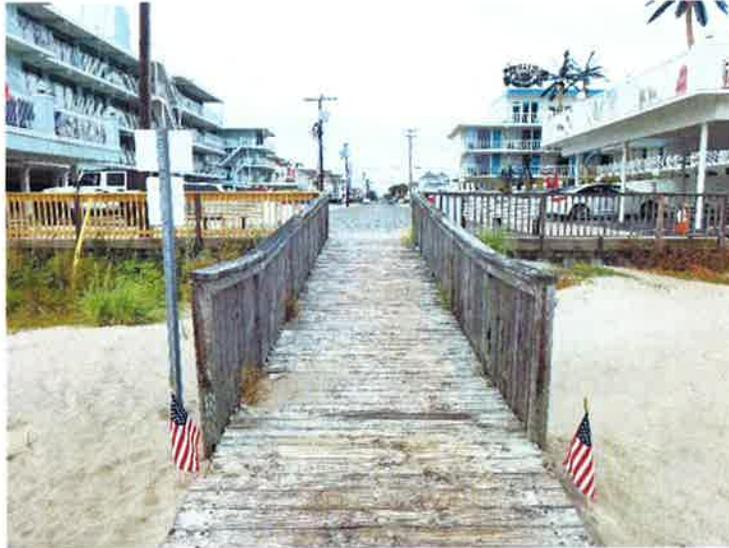
Looking west

The overall condition of this vinyl bulkhead is good. There is approximately 12-inches of sheeting exposed on the beach side. There is heavy vegetation present along the face of the sheeting. The existing timber safety railing is in satisfactory condition with some medium checks and splits in most of the posts.

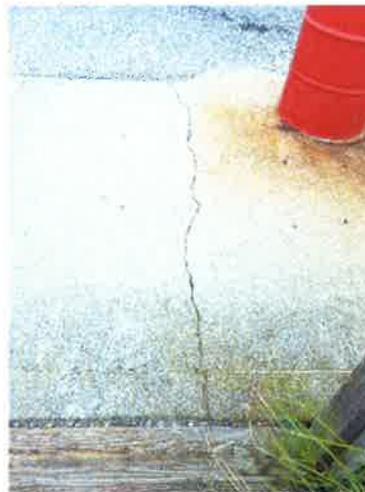
- 1. Medium-wide transverse crack along existing sidewalk.

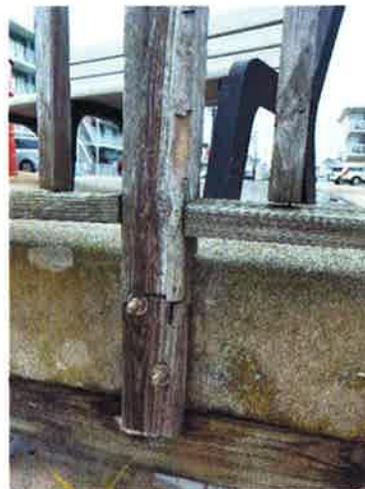
- 2. Broken post in safety railing.

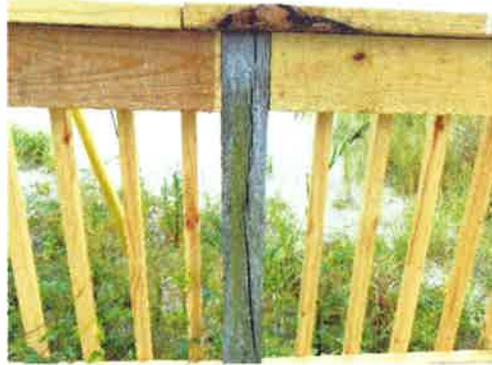
3. Medium splits and checks in timber posts of safety railing.

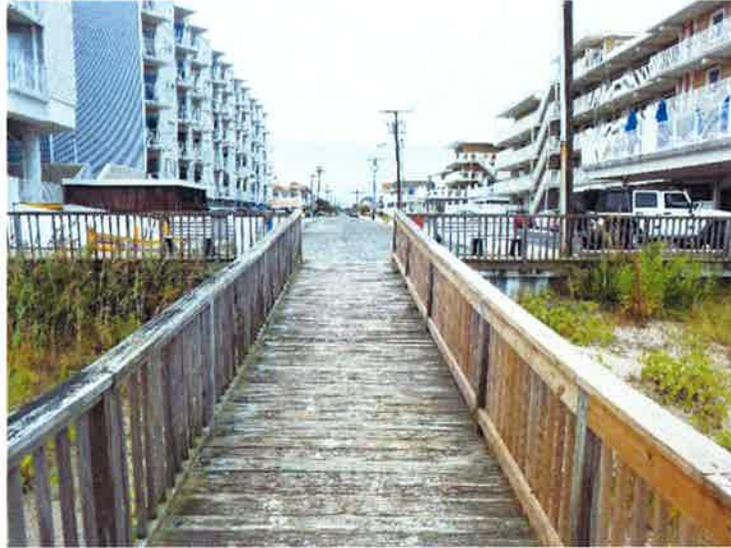
Looking west

The overall condition of this vinyl bulkhead is good. There is approximately 12-inches of sheeting exposed on the beach side. There is heavy vegetation present along the face of the sheeting. The existing timber safety railing is in satisfactory condition with some medium checks and splits in most of the posts.

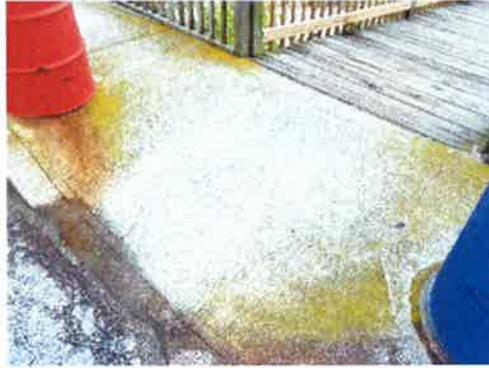
3. Non-compliant curb ramp at street end.

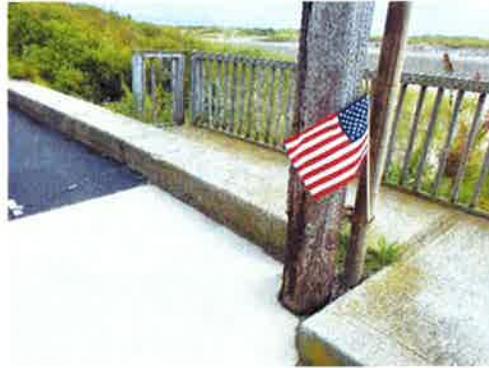
4. Excessive height curb at approach sidewalk.

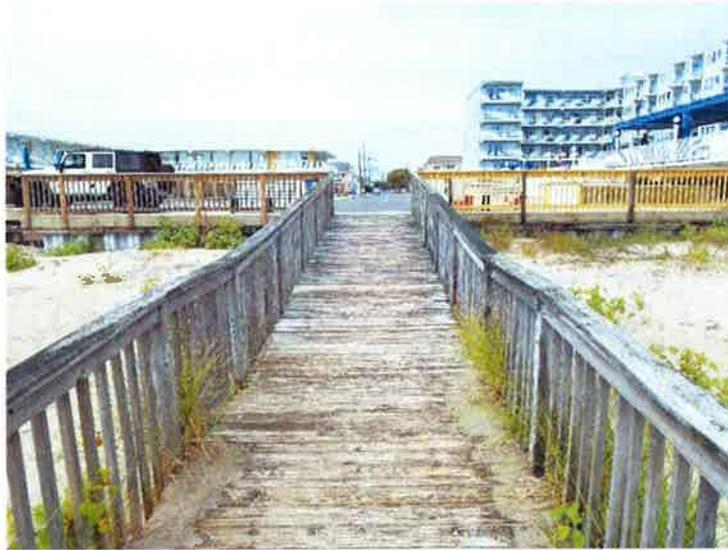
Looking west

The overall condition of this vinyl bulkhead is good. There is approximately 12-inches of sheeting exposed on the beach side. There is heavy vegetation present along the face of the sheeting. The existing timber safety railing is in satisfactory condition with some medium checks and splits in most of the posts.

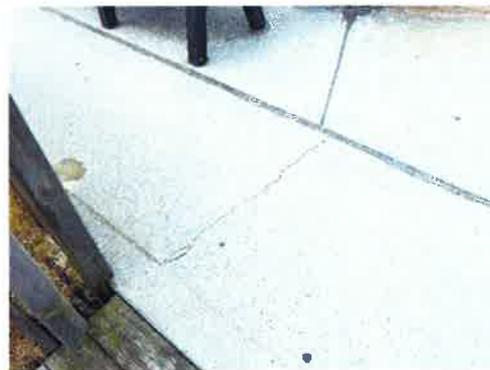
- 1. Wide transverse crack along existing sidewalk.

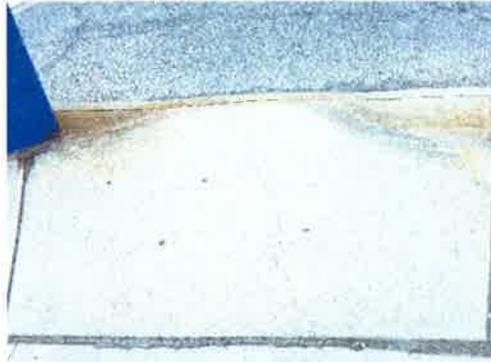
2. Non-compliant curb ramp at street end.

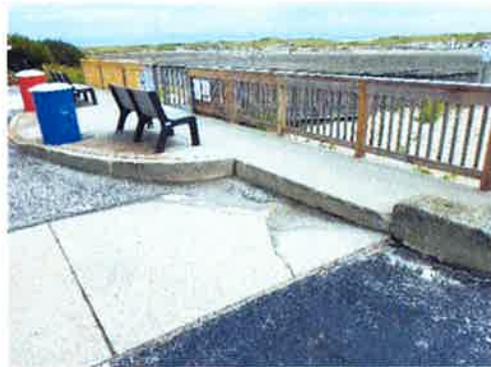
3. Excessive height curb at approach sidewalk.

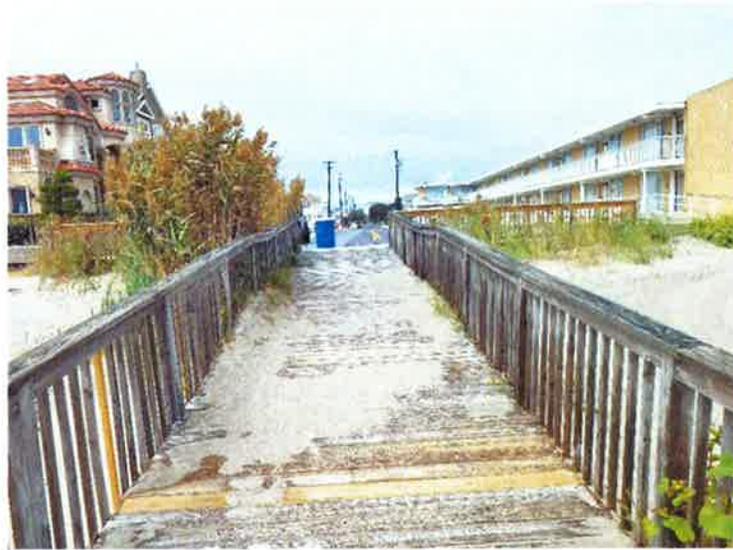
Looking west

The overall condition of this vinyl bulkhead is good. There is approximately 12-inches of sheeting exposed on the beach side. There is heavy vegetation present along the face of the sheeting. The existing timber safety railing is in satisfactory condition with some medium checks and splits in most of the posts.

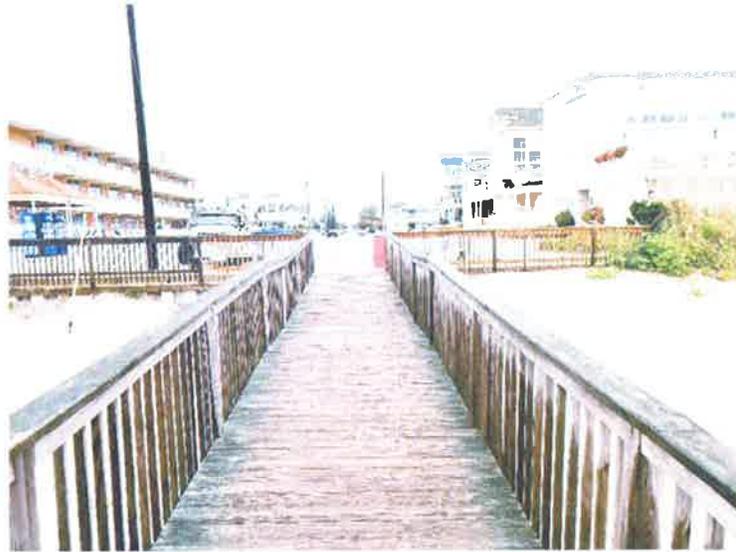
Looking west

The overall condition of this vinyl bulkhead is good. There is approximately 12-inches of sheeting exposed on the beach side. There is heavy vegetation present along the face of the sheeting. The existing timber safety railing is in satisfactory condition with some medium checks and splits in most of the posts.

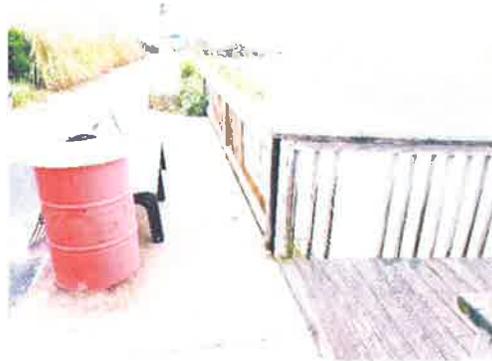
1. Missing spindles in safety railing.

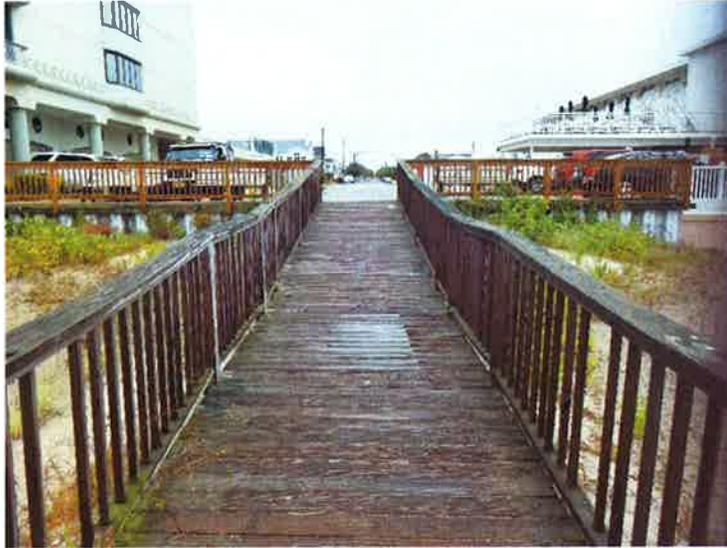
Looking west

The overall condition of this vinyl bulkhead is good. There is approximately 12-inches of sheeting exposed on the beach side. There is heavy vegetation present along the face of the sheeting. The existing timber safety railing is in satisfactory condition with some medium checks and splits in most of the posts.

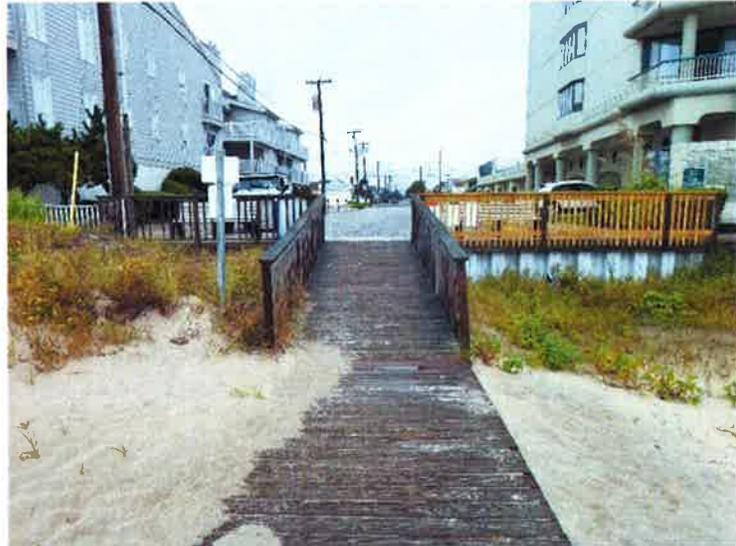
Looking west

The overall condition of this vinyl bulkhead is satisfactory. There is approximately 12-inches of sheeting exposed on the beach side. There is heavy vegetation present along the face of the sheeting. The existing timber safety railing is in satisfactory condition with some medium checks and splits in most of the posts.

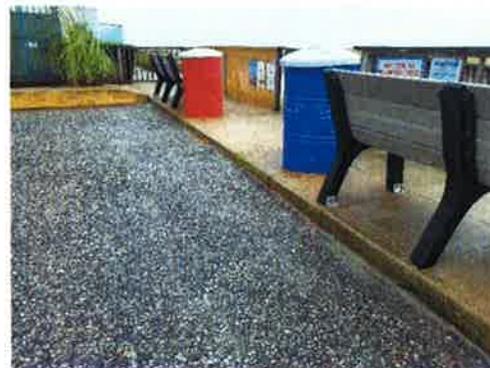
- 2. No curb ramp present at street end.

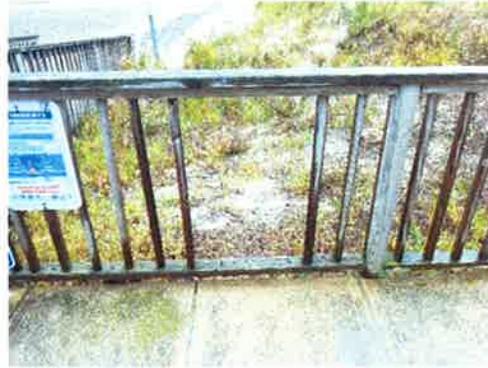
3. Missing spindles in safety railing.

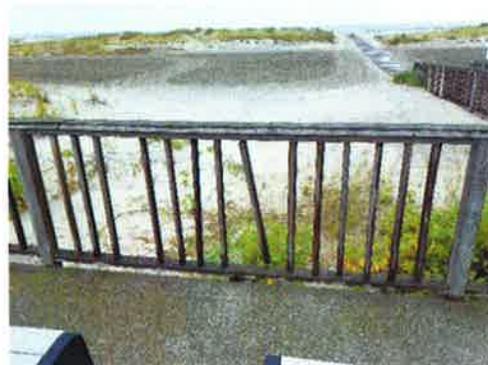
- 2. Broken and missing spindles in the safety railing.

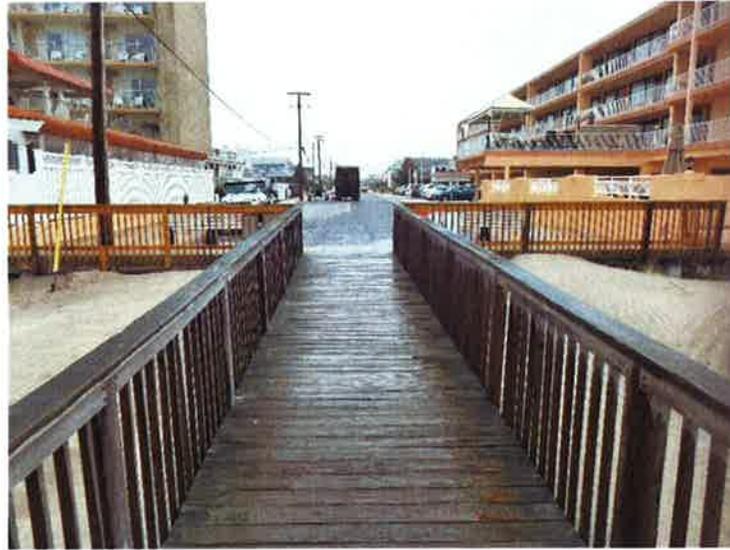
Looking west

The overall condition of this vinyl bulkhead is good. There is between 12 and 18-inches of sheeting exposed on the beach side. The existing timber safety railing is in satisfactory condition with some recently replaced sections.

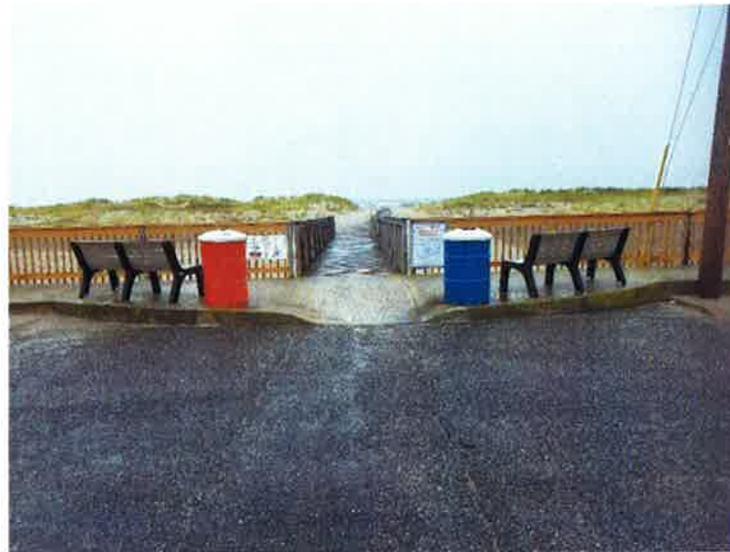
Looking east

There are medium to wide cracks in the existing sidewalk at the street end. There is also evidence of settlement at each end of the existing sidewalk creating a tripping hazard. There is also a crack in the slab behind the safety railing on the north side.

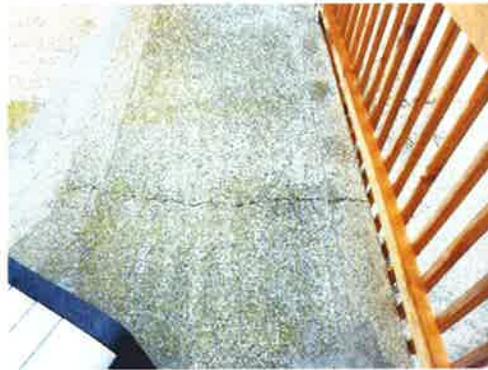
- 1. Medium-wide transverse crack along existing sidewalk.

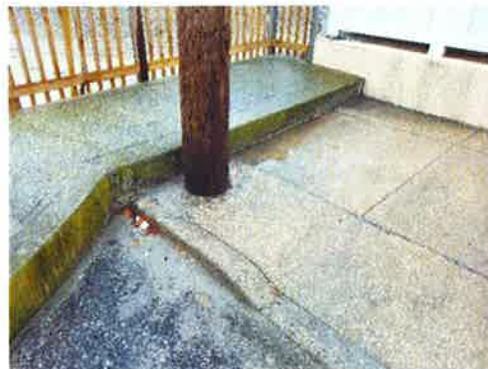
- 2. Excessive height curb on the south side of the beach access.

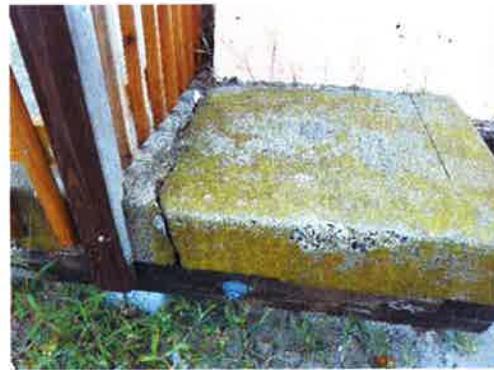
3. Crack in the sidewalk slab behind the safety railing on the north side.

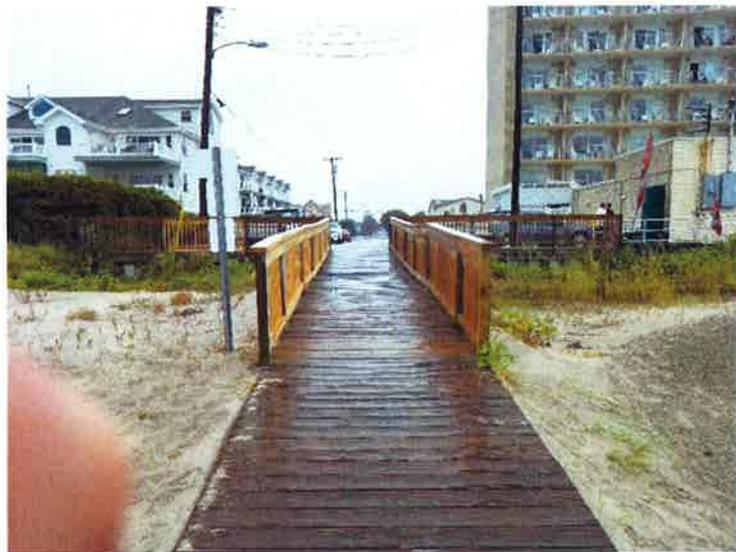
Looking west

The overall condition of this vinyl bulkhead is good. There is between 18 to 24-inches of sheeting exposed on the beach side. The existing timber safety railing is in overall good condition with some sections having been recently replaced.

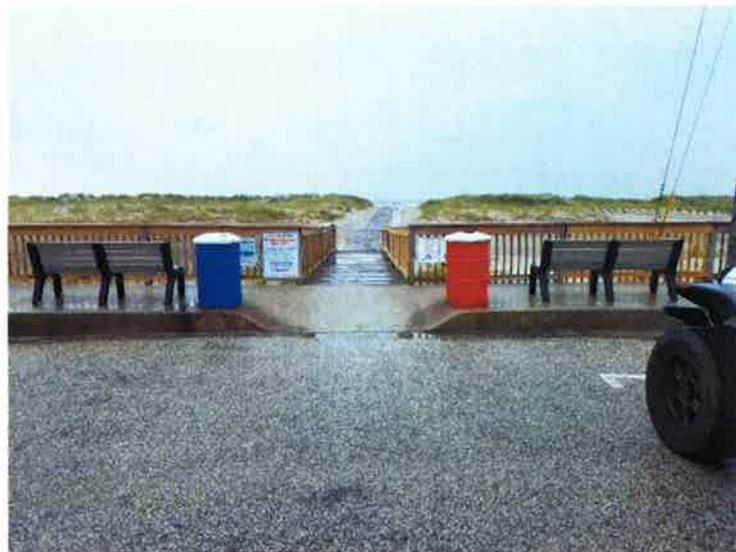
Looking east

There are medium to wide cracks in the existing sidewalk at the street end. There is also evidence of settlement at each end of the existing sidewalk creating a tripping hazard.

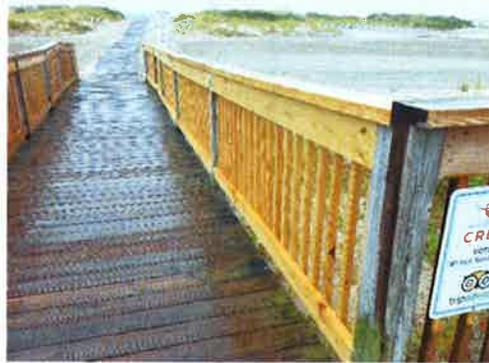
- 1. Recently replaced section of the safety railing.

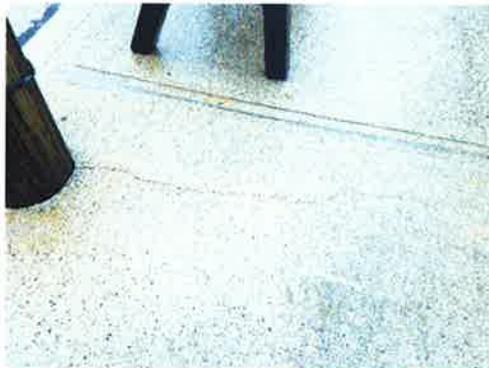
- 2. Fine crack in the street end sidewalk

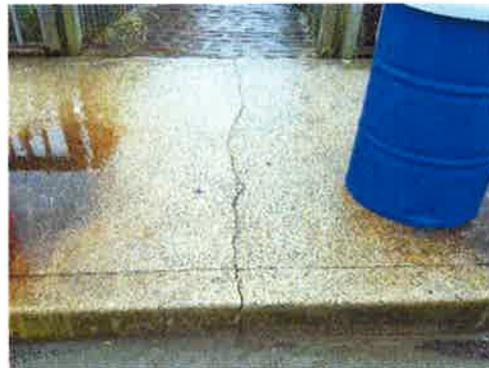
- 1. Medium-wide transverse crack along existing sidewalk.

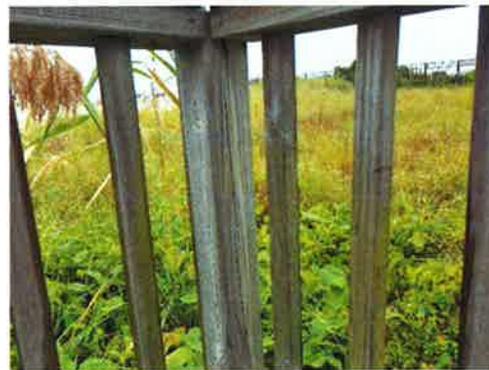
- 2. Medium splits and checks in timber posts of safety railing.

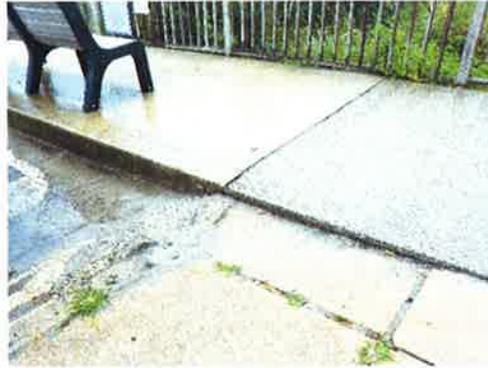
3. Settlement of the adjacent sidewalk on the south side of the street.

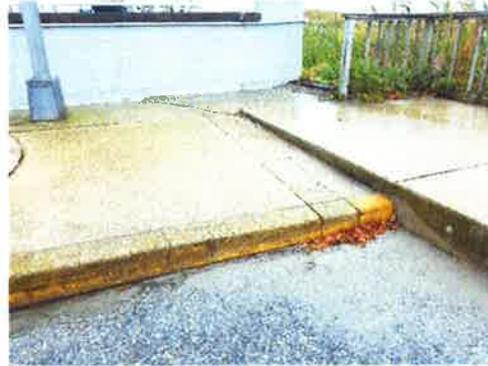
4. Uneven transition between sidewalks on the north side of the street.

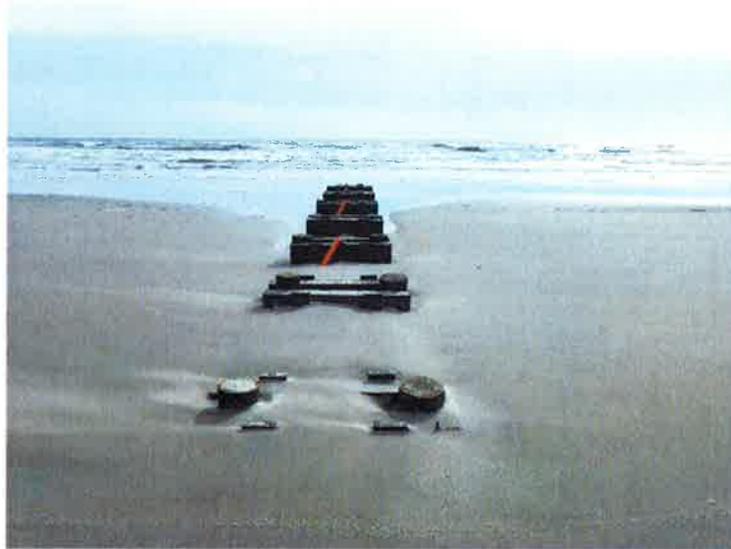
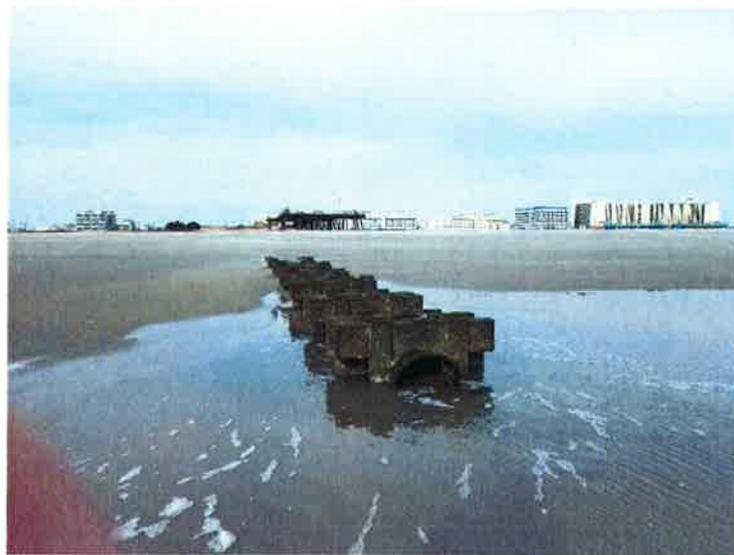
The overall condition of this outfall structure is satisfactory.

The timber pile bents providing support to the outfall pipe are in satisfactory condition, with only typical defects noted, including moderate marine growth.

The existing ductile iron outfall pipe is in good condition. All of the joints appear to be tight and free of defects.

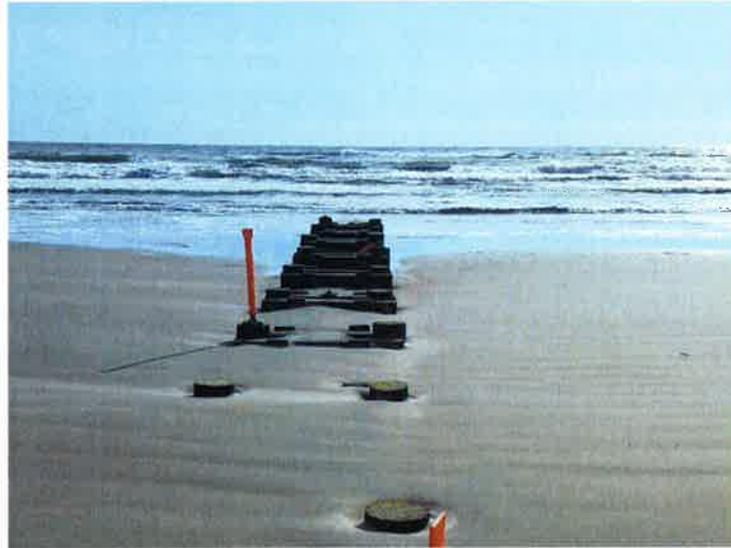
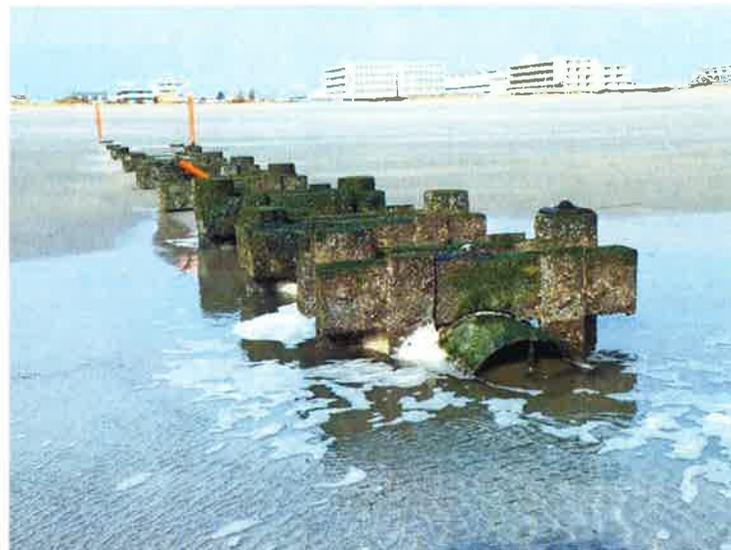
The overall condition of this outfall structure is satisfactory.

The timber pile bents providing support to the outfall pipe are in satisfactory condition, with only typical defects noted, including moderate marine growth.

The existing ductile iron outfall pipe is in good condition. All of the joints appear to be tight and free of defects.

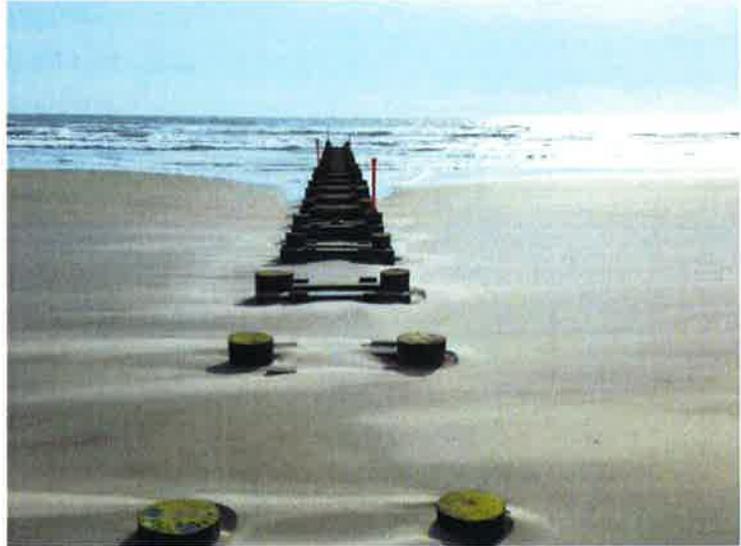
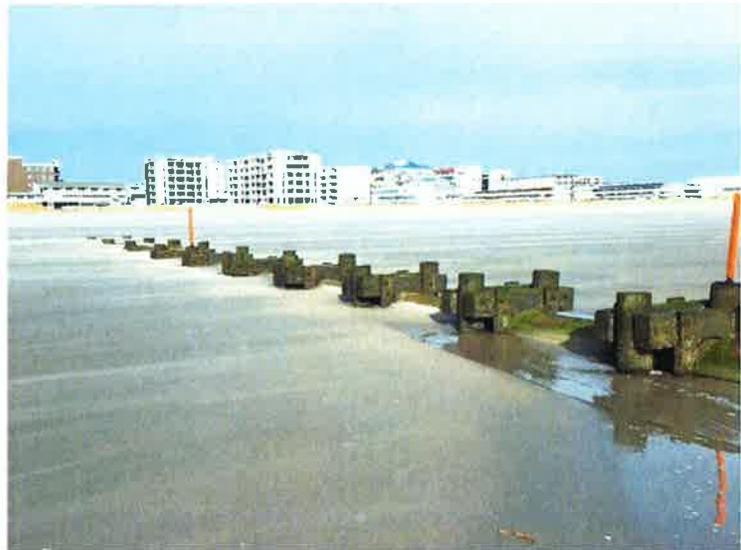
The overall condition of this outfall structure is satisfactory.

The timber pile bents providing support to the outfall pipe are in satisfactory condition, with only typical defects noted, including moderate marine growth.

The existing ductile iron outfall pipe is in good condition. All of the joints appear to be tight and free of defects.

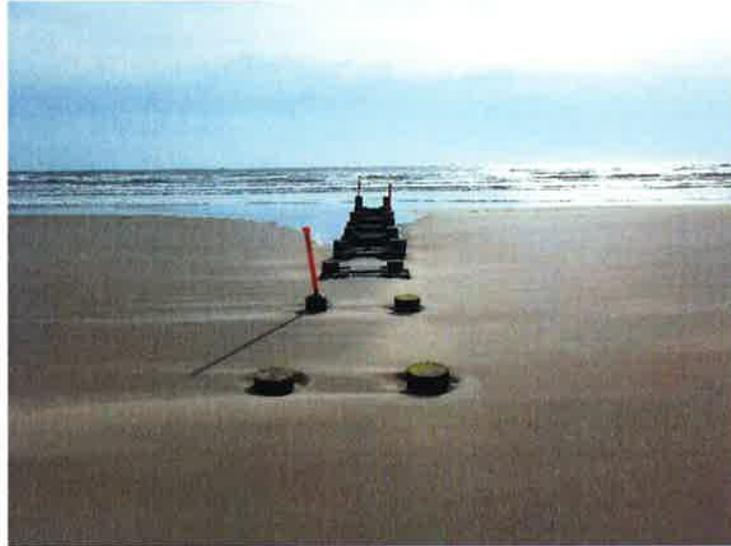
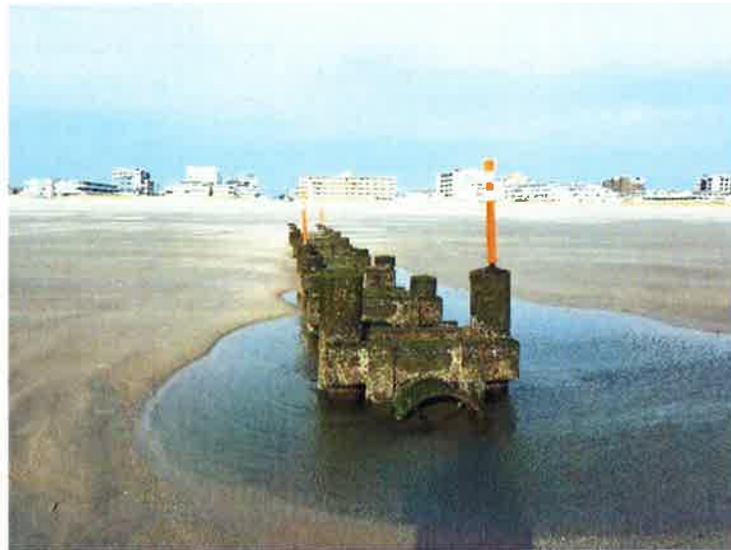
The overall condition of this outfall structure is satisfactory.

The timber pile bents providing support to the outfall pipe are in satisfactory condition, with only typical defects noted, including moderate marine growth.

The existing ductile iron outfall pipe is in good condition. All of the joints appear to be tight and free of defects.

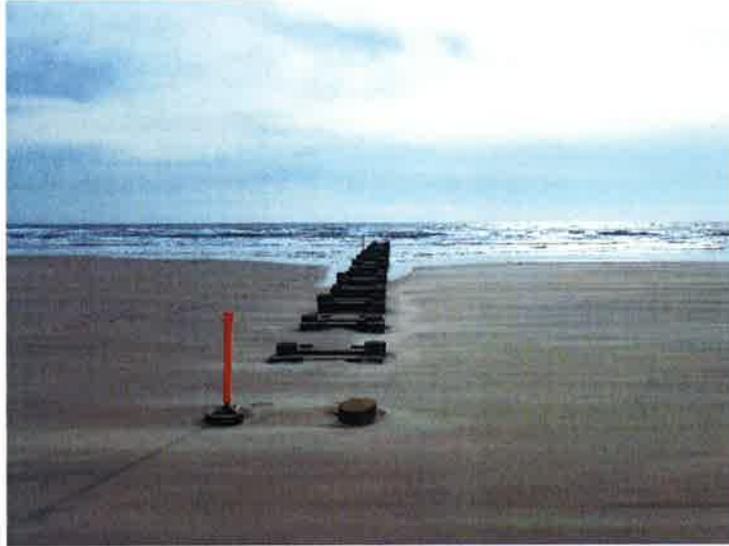
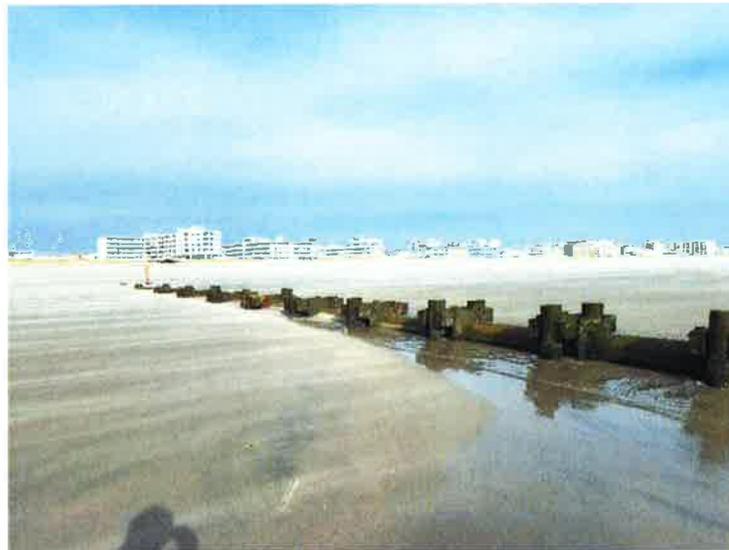
The overall condition of this outfall structure is good.

The timber pile bents providing support to the outfall pipe are in satisfactory condition, with mostly typical defects noted. One of the vertical support members is broken as shown below.

The existing ductile iron outfall pipe is in good condition. All of the joints appear to be tight and free of defects.

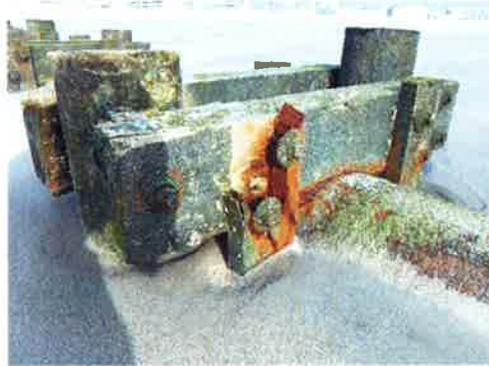
1. Broken support member at one of the timber pile bents.

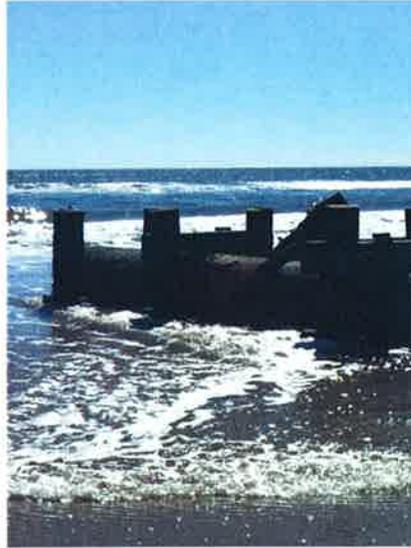
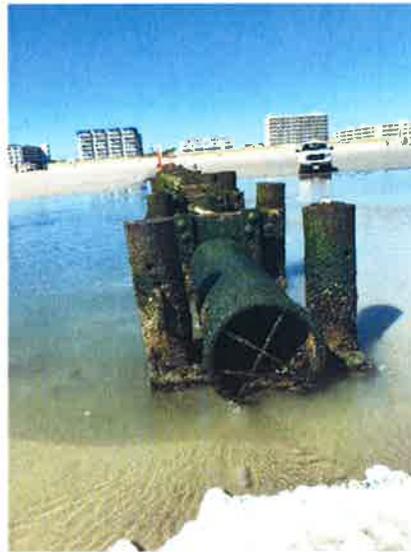
Location: Washington Avenue (Beach Outfall)

The overall condition of this outfall structure is good. This outfall was in poor condition until an emergency repair was completed in October 2017 by R.A. Walters, Inc. That emergency repair consisted of replacing several metal bolts connecting the timber pile bents that had rusted out.

The timber pile bents providing support to the outfall pipe are in satisfactory condition, with only typical defects noted, including moderate marine growth.

The existing ductile iron outfall pipe is in good condition. All of the joints appear to be tight and free of defects.
